Intel[®] Pentium[®] III Processor Specification Update

Release Date: March 2003

Document Number: 244453-047

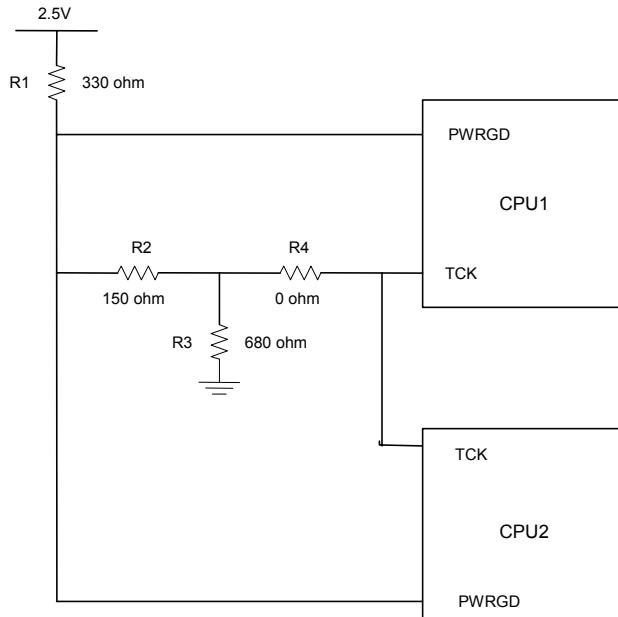
Pentium® III Processor with 512KB L2 Cache Platforms Workaround

In addition, the example workaround circuits shown do not support production baseboard test methodologies that require the use of the processor JTAG/TAP port. Alternative workaround solutions must be found if such test capability is required.

Assumes the inputs to the CPU_PWRGD are open collector signals that are Wire-ANDed together

- The example workaround circuit assumes that the PWRGD inputs into the processors are open collector. Tying the PWRGD inputs together in a Wired-AND fashion allows each processor to receive PWRGD at the same time but at the latter of the 2 separate PWRGD assertions. If separation of the PWRGD inputs to each processor is required, extra circuitry will be required.
